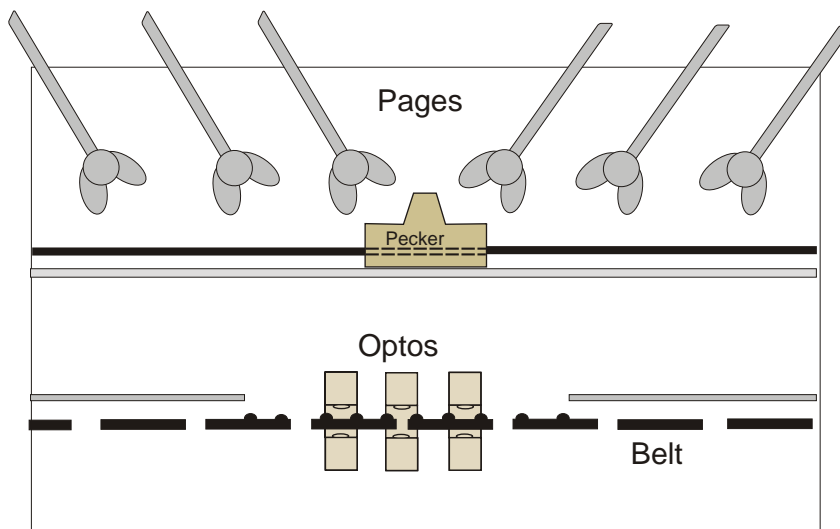
1. First check that the drive pulley is secure on the motor shaft. The shaft is dimpled to aid location and prevent relative movement. Note that a small amount of backlash in the gearbox will be present, if this appears to be not more than a few degrees it is likely that the set (grub) screw in the pulley is not engaged with the dimple. Belt must be fully slackened when carrying out this check.
2. Check belt tension, if belt is too tight, sluggish operation will result, if too slack it is possible to have tooth jumping occur.
3. From the front of the title rack ensure that the pecker tooth is accurately positioned centrally between two pages. Now adjust the optos such that the centre one is over a hole in the belt and the outer ones are evenly just clear of the next holes. It is important that this is carried out accurately

4. Check that the belt is free to move and is not impeded by the optos. Slots in the opto bracket and P.C.B. allow adjustment sideways, back and forwards also up and down
